FINDING NEW STRENGTH

Strengthening of a defective bridge in the Tver region of Russia involved installation of new towers and cables to support the main spans. **Alexey Surovtsev** and **Yury Devichinsky** report

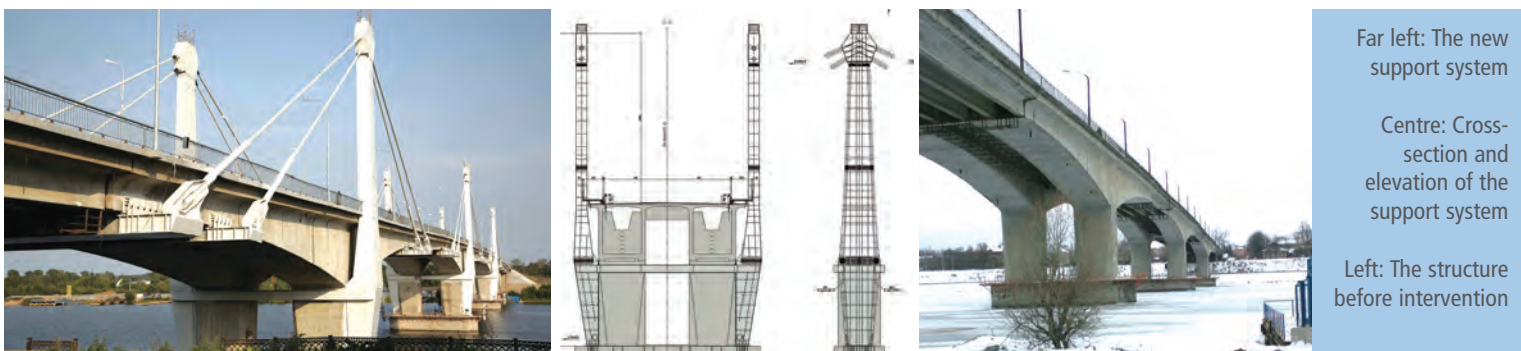
Far left: The new support system

Centre: Cross-section and elevation of the support system

Left: The structure before intervention
